The primary aim of the form is to evaluate the hazards present at a specific commercial, public service premises, educational facility or Bring Bank Sites, which have the potential to cause a risk during the collection of refuse or recycling.

Name of Premises:	The Drift				
Full Address:					
Telephone No:					
Items to be collected:		Number		Size	
Reversing assistant required –Yes/No			Overall risk rating- L/M/H		
Checklist	Yes	No	Notes		Hazard Rating L/M/H
APPROACH TO PREMISES					
Near school/hospital/ community centre etc.		X			L
Traffic level i.e. busy; average; quiet	QUIET				L
Any overhead obstructions i.e. trees/cables	X		Low overhead trees with the potential to damage vehicle		H
Local speed limit (if so, state 30/20 etc.)	N/A				L
Are parked cars a problem		X			L
Are the premises in pedestrian areas		X			L
Is the entrance on a blind bend		X			L
Can the collection be made from the kerbside		X			M
Does the vehicle need to reverse		X	If oncoming traffic met vehicle would have to reverse (max 400m)		L
Is a turn required during the reverse		X			L
Is the entrance concealed		X			L
Do you have to drive over the pavement		x			L

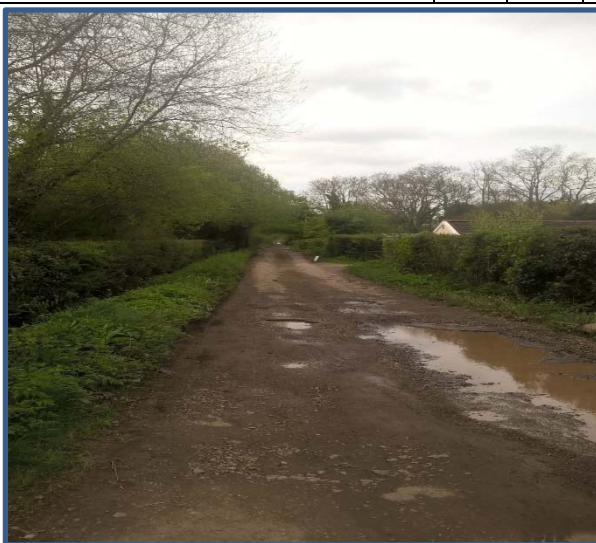
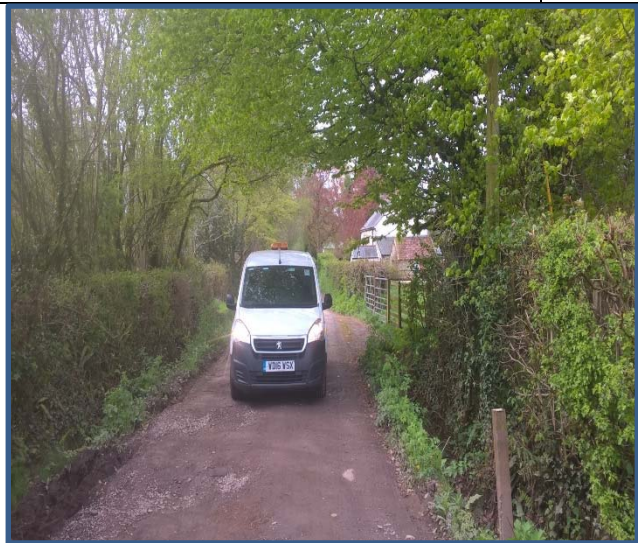
OTHER NOTES/OBSERVATIONS
<p>The Drift is a narrow unadopted highway with a very poor level of maintainaince, resulting in a potholed and uneven surface in a very poor state of repair</p> <p>The edge of the highway is undefined, running on to a slim grass verge on the eastern flank immediately abutted by a drainage ditch. Consequently the grass verge is often saturated and unstable. The risk of vehicle becoming trapped in the ditch is very high</p> <p>Overhanding trees and greenery along the route reduce light levels, increasing difficulty of collection particuarly when dark.</p> <p>Along the Drift, there are no parking places or turning areas for vehicles to pass, should vehicle meet a vehicle would have to reverse the full length of the highway, this is particularly risky given the condition of the road and lack of definition of the highway. Banking a vehicle in these cirmcumstaces is a high risk activity given narrowness of the road and absence of usable verges/walkways for the Reversing Assistant to use. Additionally, walking directly behind the vehicle the risk of slips trips and falls are high due to potholing and poor road condition.</p>
